AFRL-VA-WP-TR-2003-3088

**INVESTIGATION OF THE EFFECT OF
CORROSION PITTING ON FATIGUE
LIFE OF ALUMINUM STRUCTURE**

Eric J. Tuegel

OCTOBER 2003

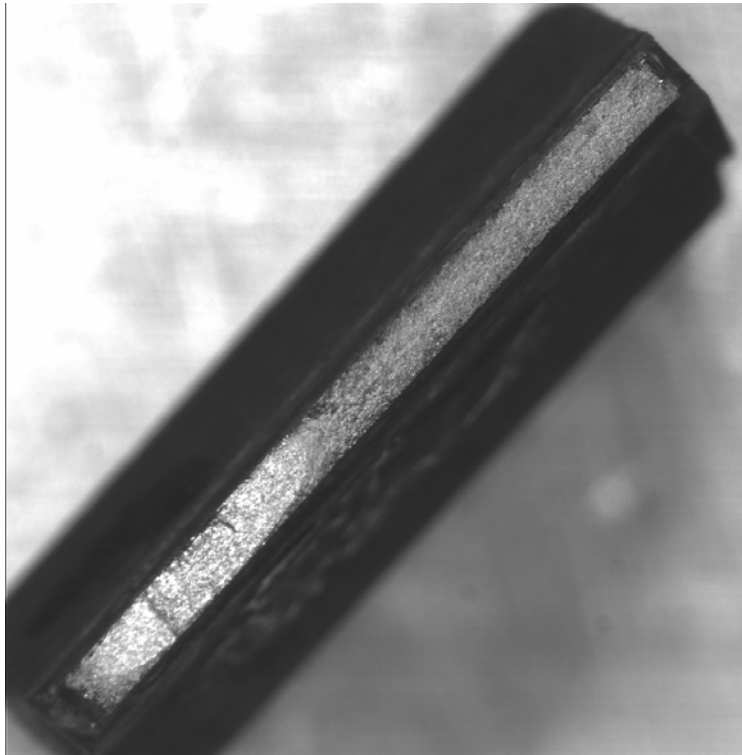
Figure A-14. Fracture Surface of Specimen 5877.

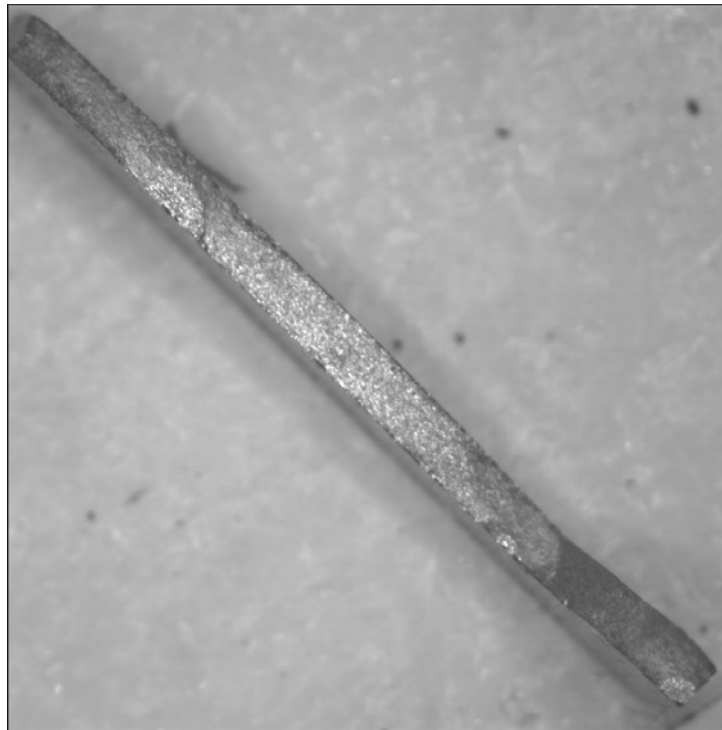
Figure A-15. Fracture Surface of Specimen 5878.

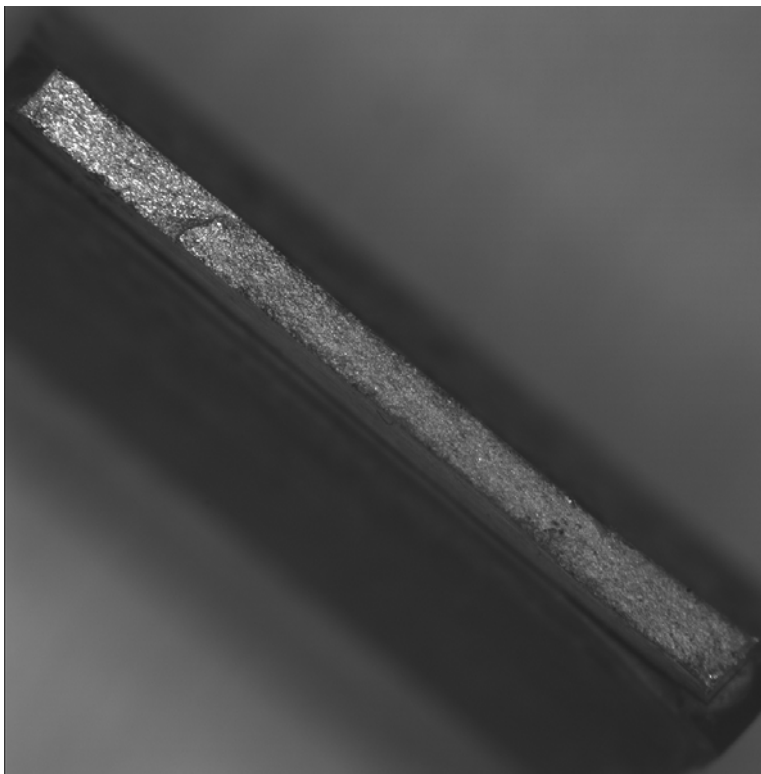
Figure A-25. Fracture Surface of Specimen 5945.

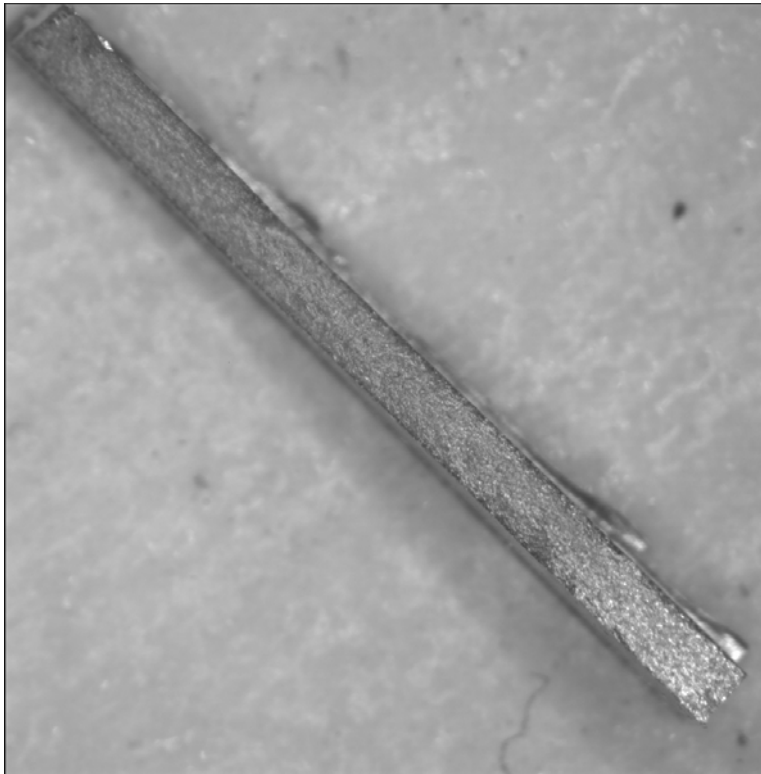
Figure A-26. Fracture Surface of Specimen 5946.
